**Engineering and Organizational Issues Related to
the World Trade Center Terrorist Attack**

**Overview of Damage to Buildings
Near Ground Zero**

By Michel Bruneau, Andrew Whittaker and Andrei Reinhorn

March 2002

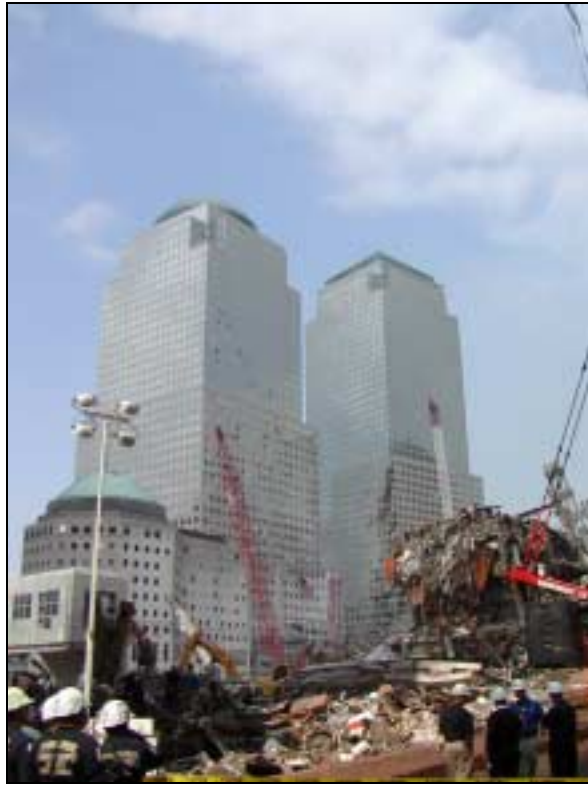
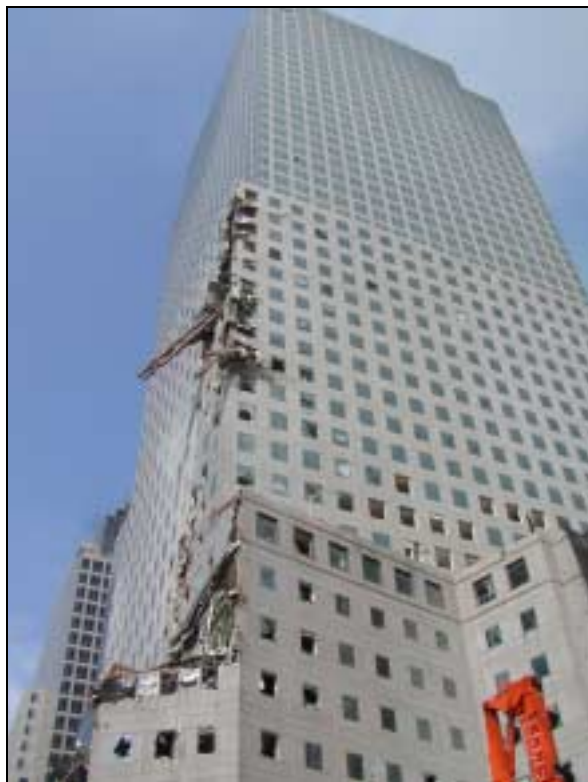
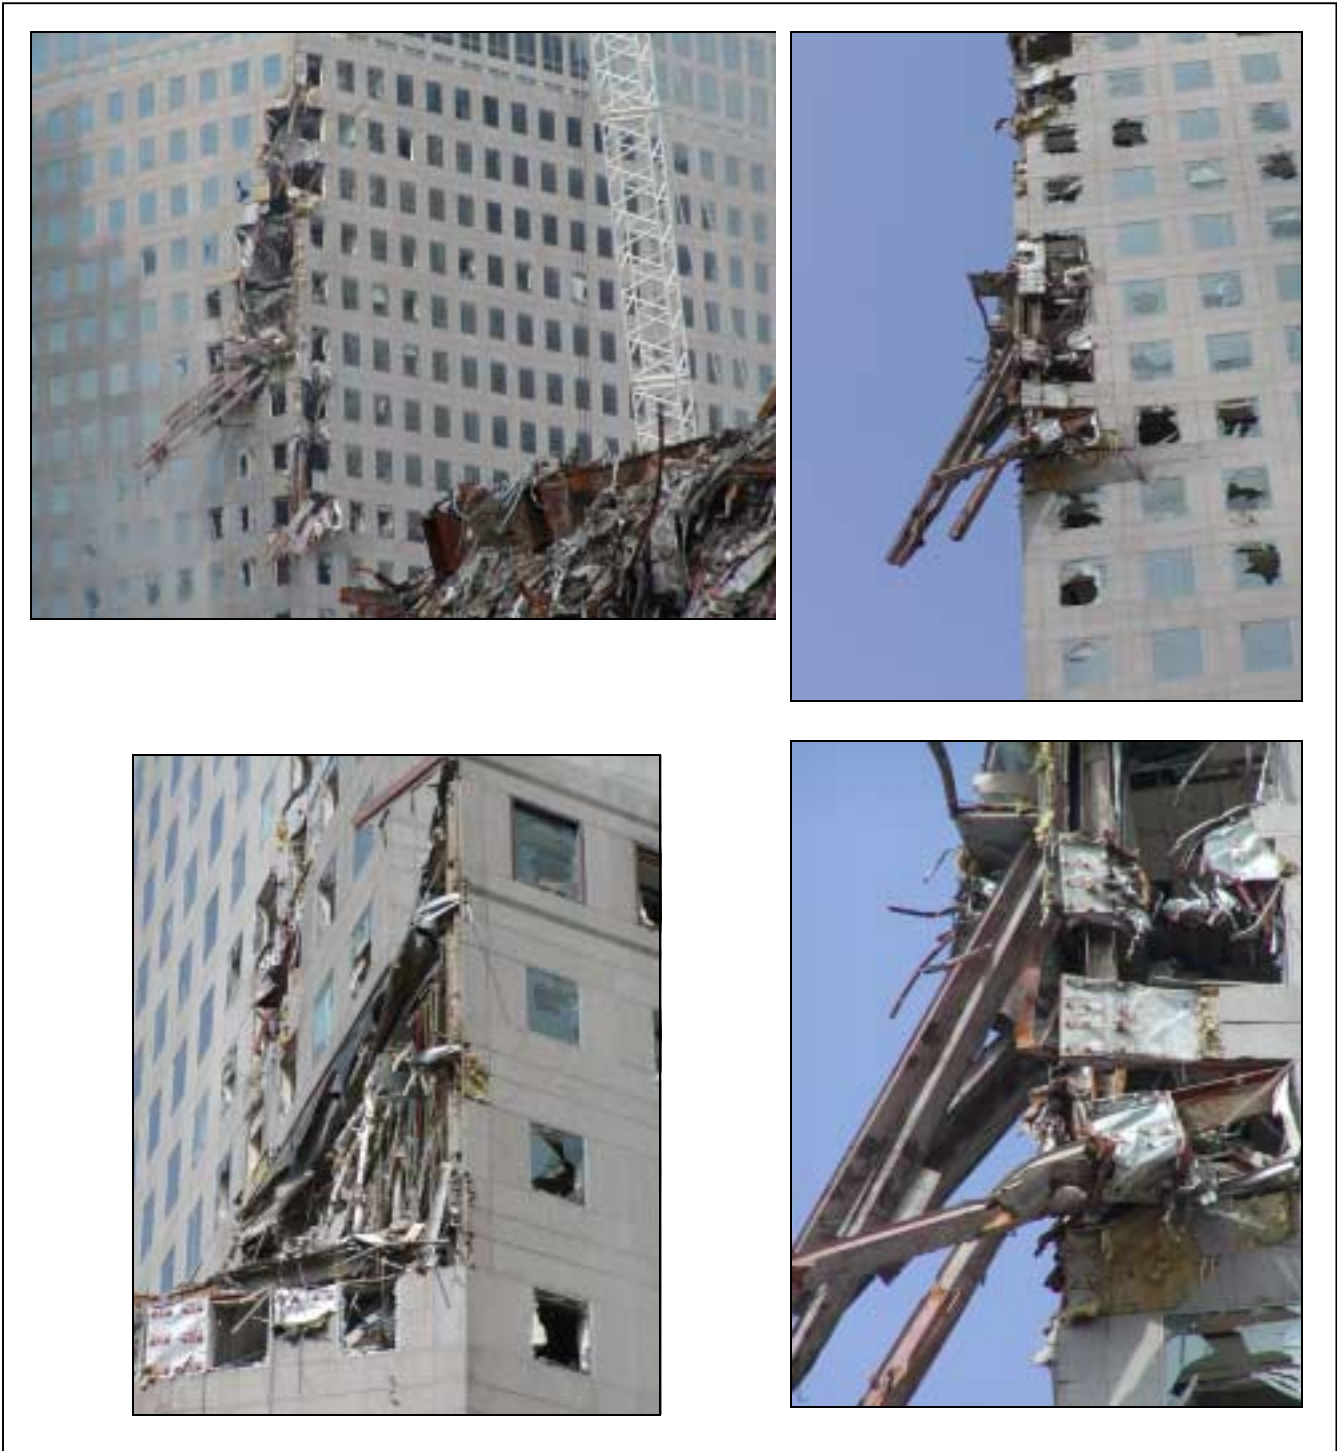
A number of the perimeter column modules (see Figure 3.2) from the collapsing towers penetrated the façade of 3 World Financial Center, significantly damaging the building's outer shell (see Figure 3.20). Parts of perimeter-column modules from one of the towers were still protruding from the façade of the World Financial Center tower during the two site visits. These pieces of debris had been secured to the building at the time of the first visit on September 21, awaiting a solution to remove them without jeopardizing the integrity of the gravity-load-resisting system.

Figure 3.20. Damage to the façade of 3 World Financial Center

Figure 3.20. (continued) Damage to the façade of 3 World Financial Center

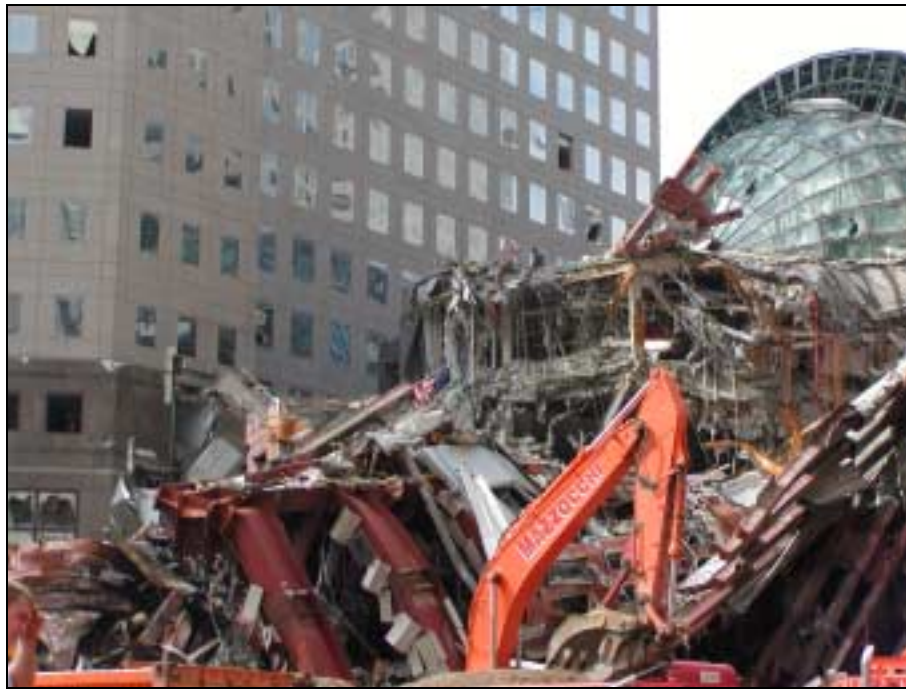
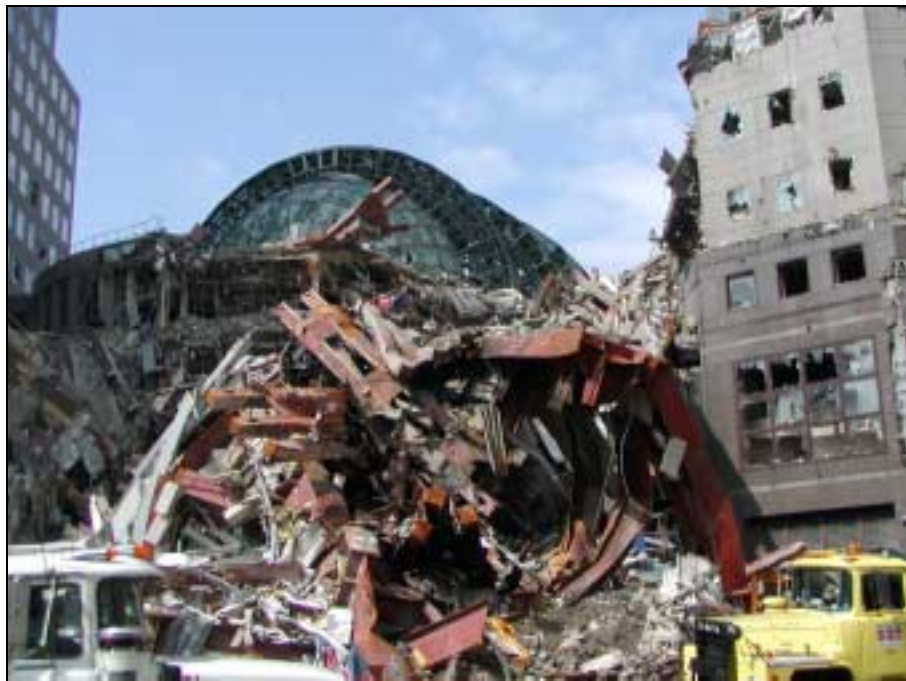
The Winter Garden, located between the two towers of World Financial Center, was severely damaged as numerous pieces of debris penetrated the glass-ceiling of this steel-framed building (see Figure 3.21).

*Figure 3.21.
Severe damage to
the east side of the
Winter Garden*

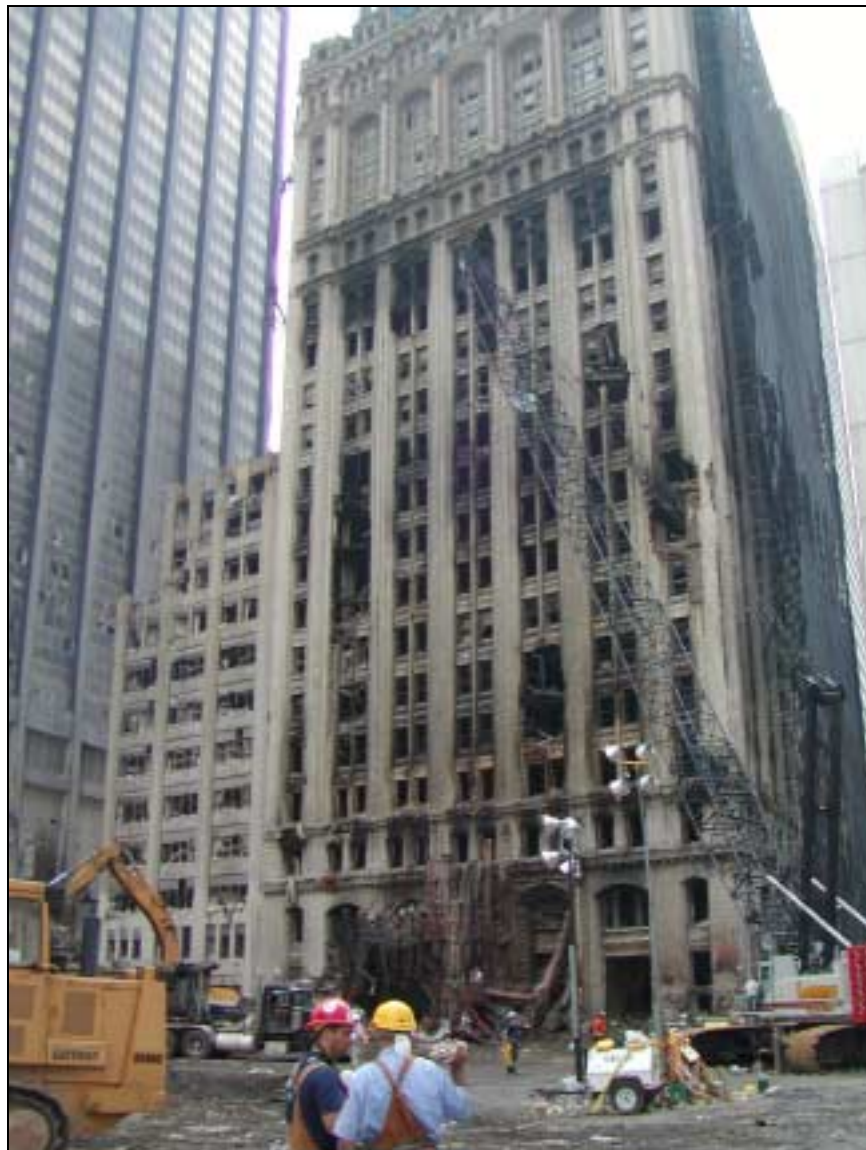
The 90 West Street building was hit by burning debris from the collapse of World Trade Center 2, which started a number of small fires as evinced by damage to the façade (Figure 3.22). A large multi-ton segment of the façade of WTC 2 lodged at the base of the building, but caused only modest damage to the building (Figure 3.23).

Figure 3.22. 90 West Street building

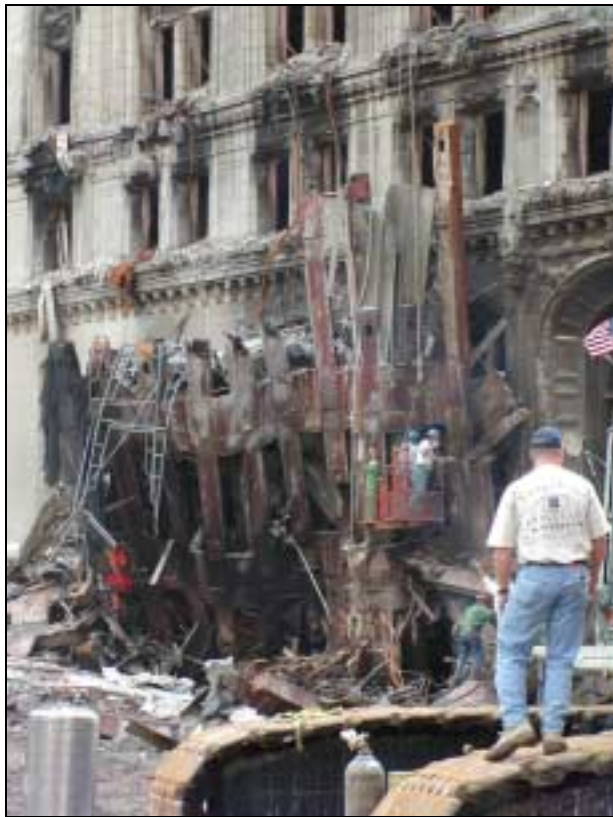
Figure 3.23. Large multi-ton segment of the façade of the WTC 2 lodged at base of the 90 West Street building

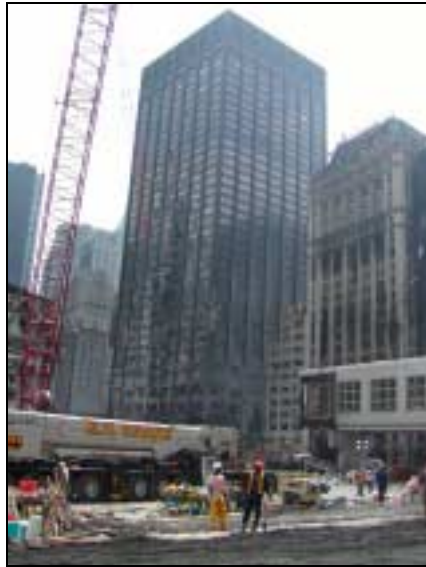
The Banker's Trust Building at 130 Liberty Street was badly damaged by falling debris from the collapse of World Trade Center 2 (Figure 3.24). A large piece of debris, a perimeter column module from WTC 2, that was still lodged in the 6th story of the building at the time of the site visits, ripped a twenty story gash in the north façade of the building, from the 26th to the 6th story (see Figure 3.25), obliterating a column from the perimeter frame at that location, with much interior damage (see Figure 3.26).

Figure 3.24. Banker's Trust Building, 130 Liberty Street

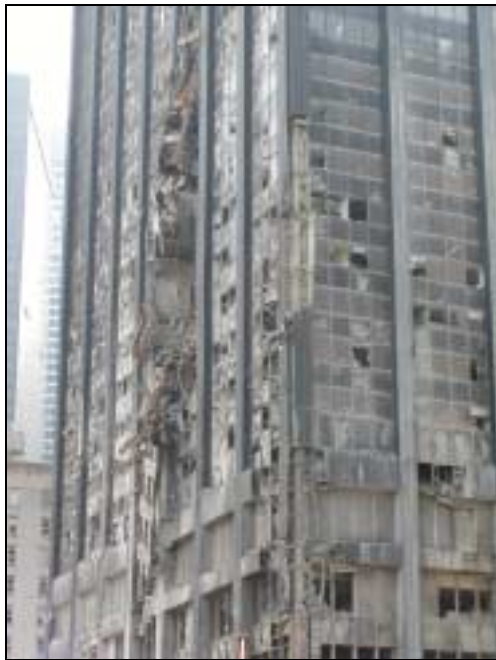
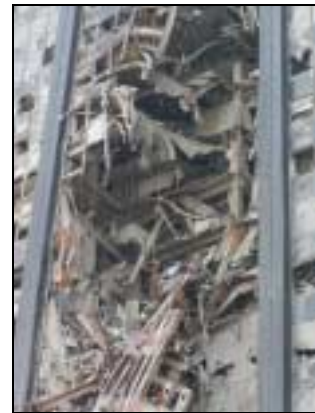
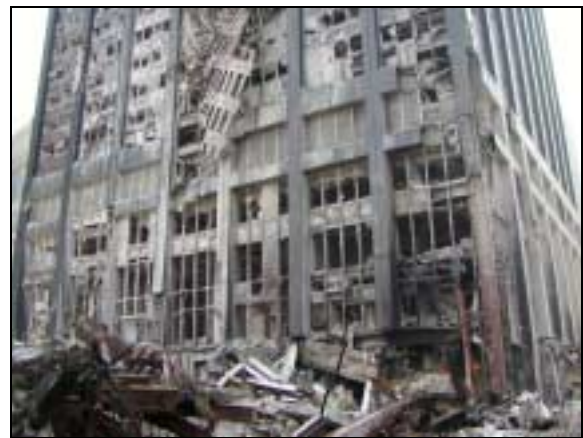
Figure 3.25. Twenty story gash in the north façade of the building, from the 26th to the 6th story

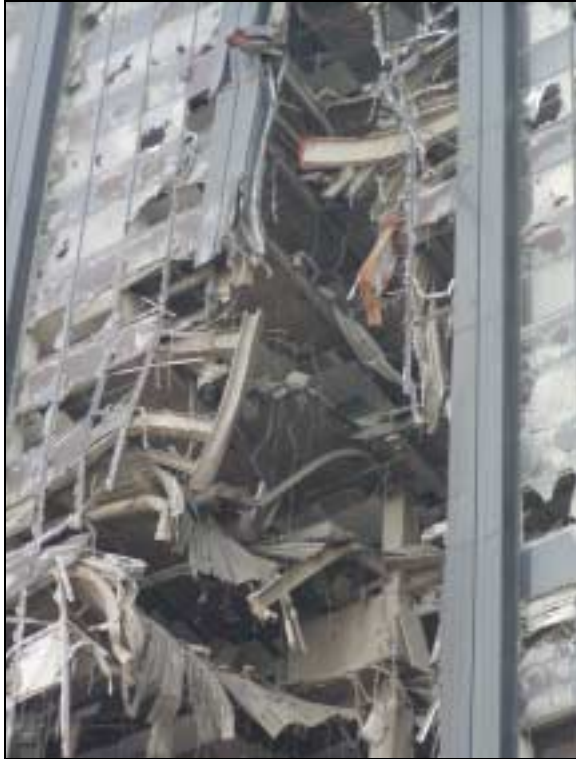
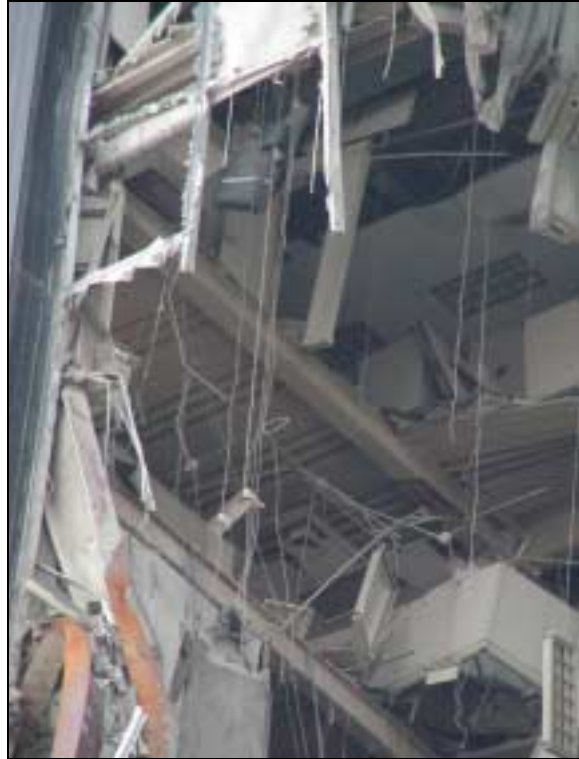
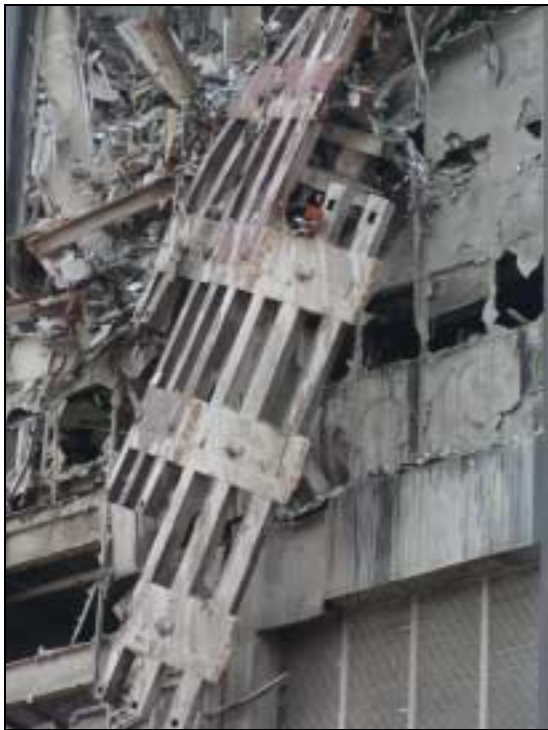
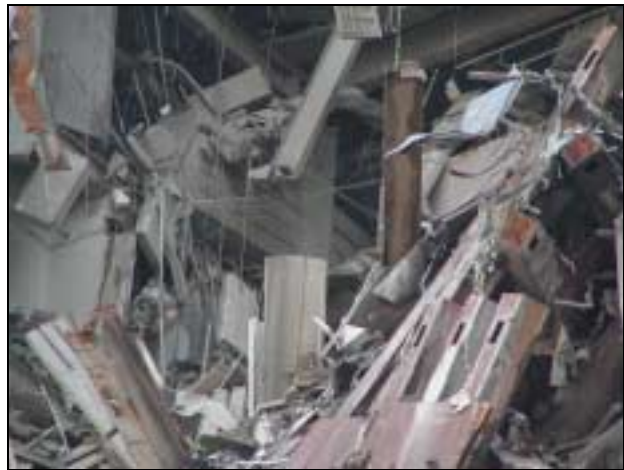
Figure 3.26. Exterior and interior damage to the Banker's Trust Building

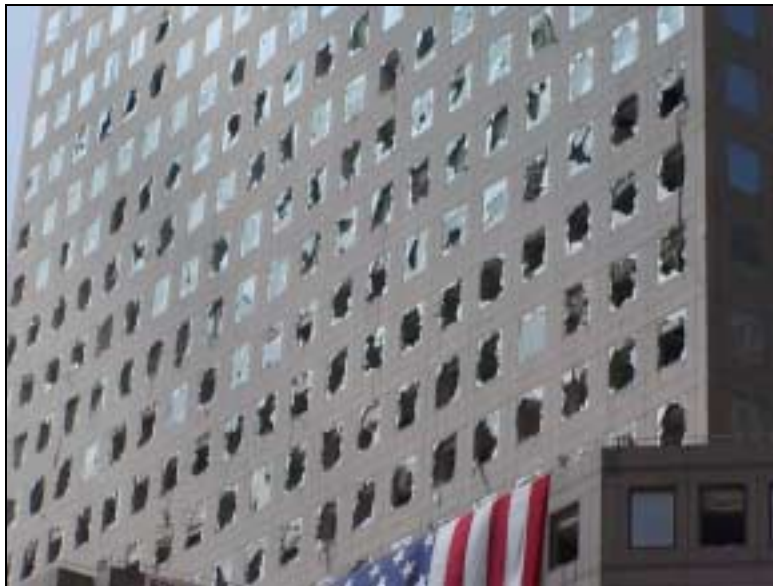
In some instances, extensive nonstructural damage was observed in the absence of visible structural damage. For example, all the windows were broken in a building immediately located across from the collapsed World Trade Center 7. Two World Financial Center exhibited similar damage (Figure 3.27). However, in some instances, many of these windows were also broken by the fire-fighting crews. The Millennium Hilton, across Church Street from WTC 5, suffered major cladding damage, but appeared to be otherwise structurally sound (Figure 3.28).

Figure 3.27. Broken windows in 2 World Financial Center

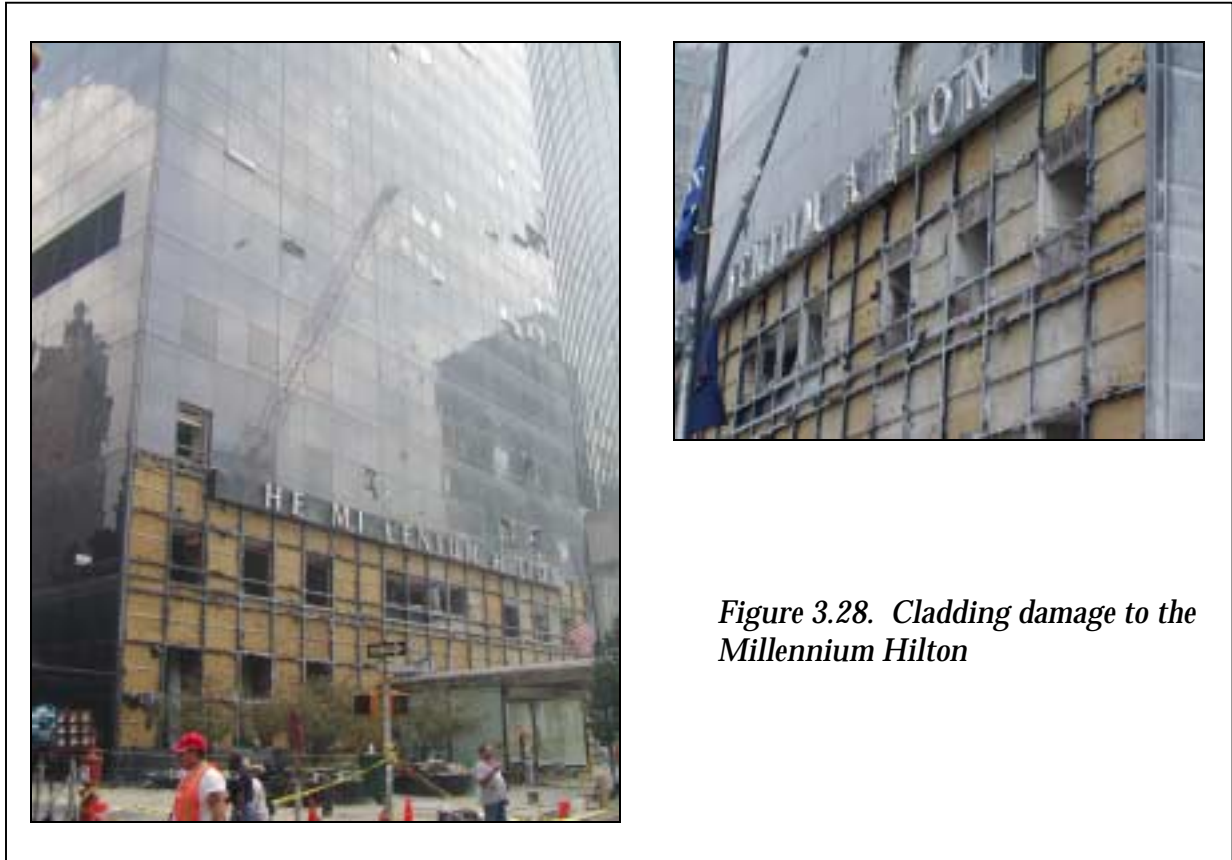
Figure 3.28. Cladding damage to the Millennium Hilton

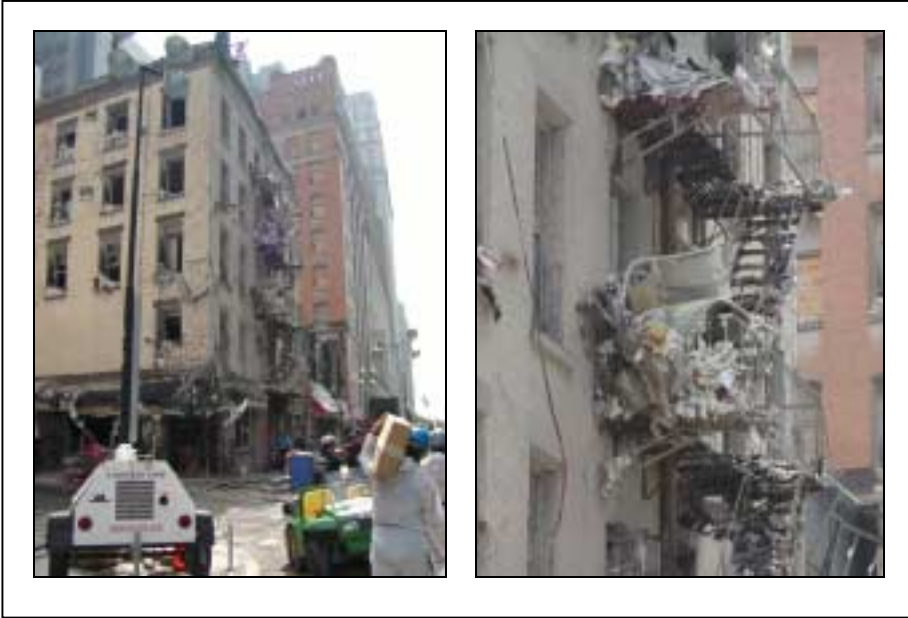
Finally, although the miscellaneous debris were removed from the street by the time of the reconnaissance visit, some assessment of the quantity of dust and miscellaneous debris that probably littered the entire site on September 11 was provided by the amount of such debris still present at less accessible locations, such as in the emergency stairs of a small building adjacent to Ground Zero (Figure 3.29). Among the debris from the towers was a substantial amount of paper, which accumulated on the outside windows of buildings in the area.

Figure 3.29. Debris in the emergency stairs of a small building near Ground Zero
